**River Restoration '96
– Session Lectures Proceedings**

**International Conference arranged by the
European Centre for River Restoration**

**National Environmental Research Institute
Ministry of Environment and Energy, Denmark**

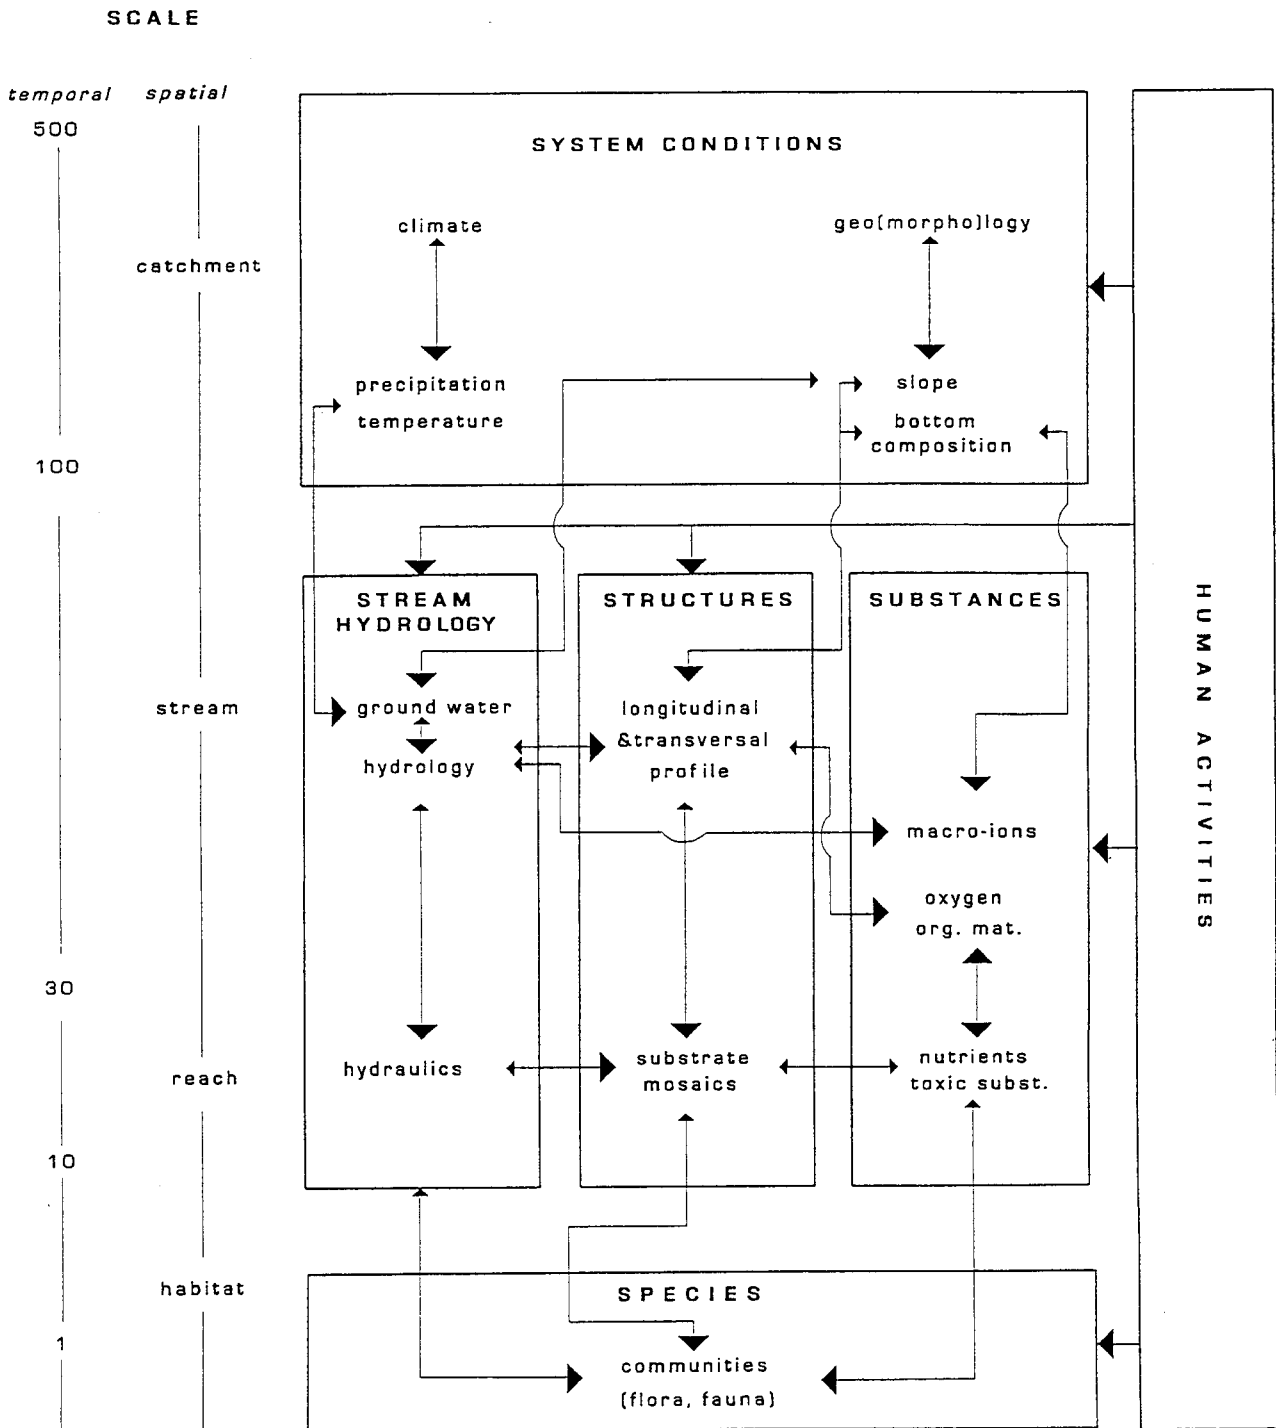
Figure 1. Interaction scheme of controlling factors and hierarchical scale levels of the 5-S-model. Objectives

1. **System conditions** comprise the processes related to climate (temperature, rainfall), geology and geomorphology (like slope, soil composition). System conditions are composed of ultimate controlling factors and are boundary conditions for a stream. The system conditions set the possibilities and limits for stream ecosystem functioning. Ultimate controlling factors continuously interact with a stream at a high hierarchical scale level in space (the catchment), as well as in time (+/- 100 years). Generally, system conditions can not be changed by management. Human activities influence this level through, for example, atmospheric deposition and climate change. Stream rehabilitation does not focus on these factors but one has to consider the effects of these boundary conditions as well as the long term effects of change.

2. **Stream hydrology** characteristics are set by the system conditions. Stream hydrology comprises, at the scale level of catchment, the hydrological processes, like infiltration, ground water flow, seepage, run off and discharge. At the level of stream and habitat stream hydrology comprises hydraulic processes, like current velocity and turbulence. Stream hydrology refers to the water quantity parameters. The direction of the water flow strongly influences the direction of all other parameters in the system. The two main directions of flow are one running from the boundary of the catchment towards the stream (lateral) and one running from source to mouth of the stream (longitudinal).

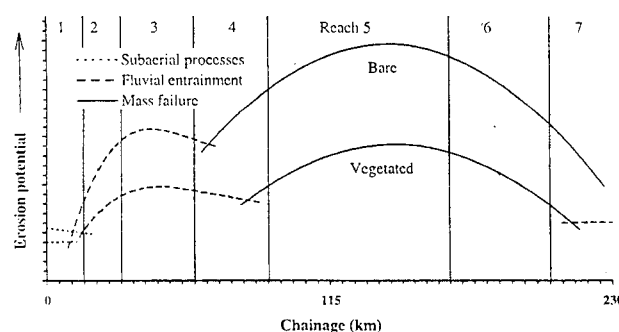
Figure 4. Spatial zoning and efficacy of erosion process for the vegetated and bare banks on the Latrobe River.

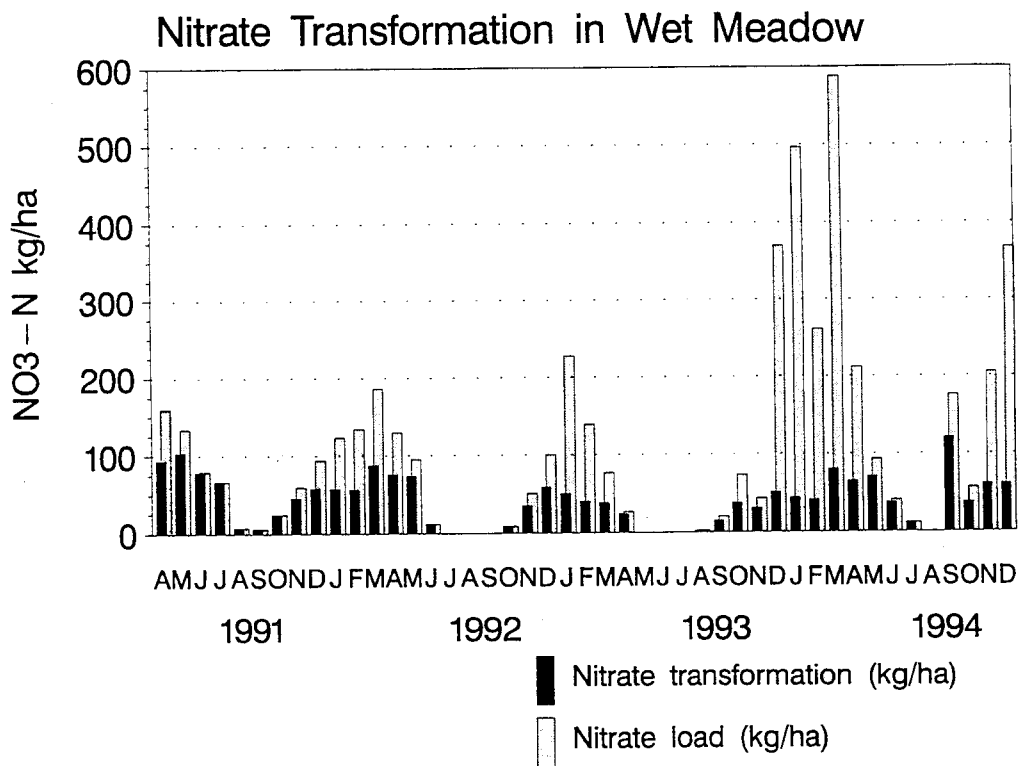
Figure 2. Nitrate transformation and nitrate load to the study area, 1991-94.

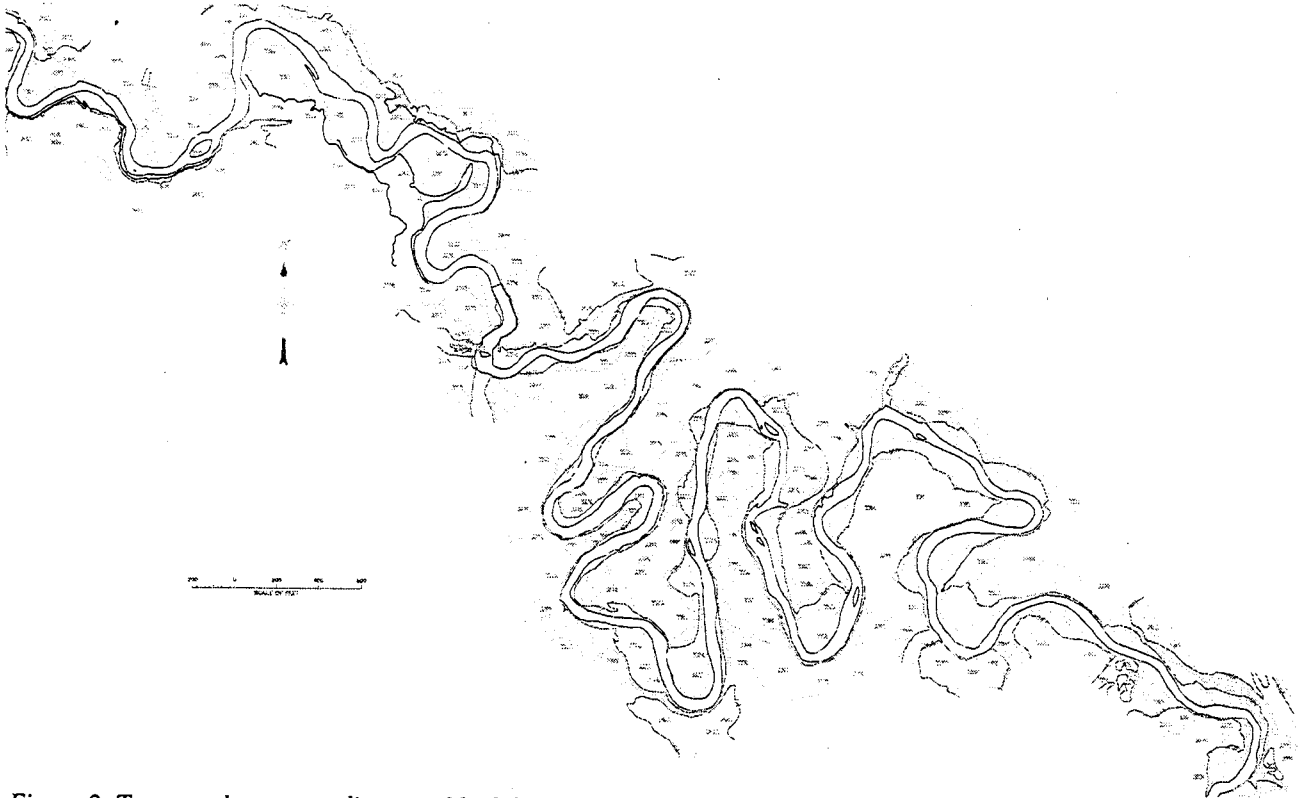
Figure 2. Topography surrounding roughly 6.6 km reach of demonstration project.

The demonstration project is an evaluation of low cost grade control and planform control designs on a 6.6 km reach of the stream where down cutting and bank erosion are most active Fig. 2 shows the topography surrounding the demonstration reach. The following sections describe the components of the structures, first the planform control, and then the grade control.

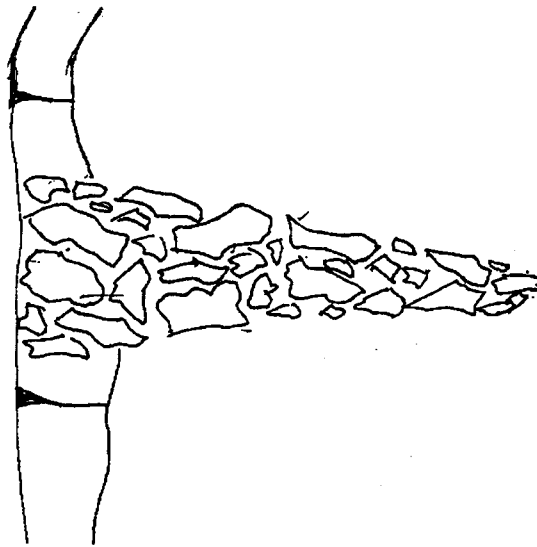
Figure 3. Plan of typical barb, perpendicular orientation.

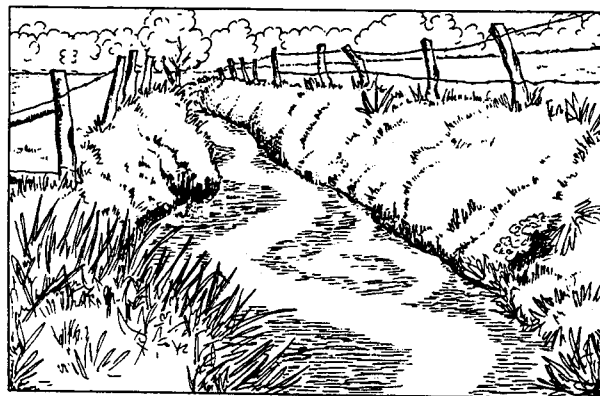
Figure 6. Open your eyes - the brook shows us its needs.

In many cases the brooks show us what to do, published e.g. in (7). Fig. 6 gives such an example: From an in former times and in upstream reaches still 0.5 m wide brook this stretch by continuing dredging activities has been devastated up to a 2 m deep incised rectangular profile with a width of 2-3 m. Inside this cross section the brook meanders showing us its natural demands. - With the help of interested people, possibly collecting necessary money by themselves in-stream measures like narrowing the low water cross section to induce running waters' characteristics, planting alders and establishing gravel banks result in the typical pool-riffle structure of most running waters. Groups of citizens working for a better urban environment, so-called "Bachpatenschaften" (brook sponsorship schemes (8)), are able to conduct such works, including monitoring and removal of refuse, measuring biological and chemical situations, report bad and good situations including PR-activities in local newspapers etc. No matter of age or profession - every person is able to engage: The „Bachpatenschaften“ at the moment are dominated by pupils' groups, NGO activists and neighbourhood alliances. These groups should be supported effectively to give the urban population an impression of the worth of nature in their neighbourhood and to encourage them for further activities.

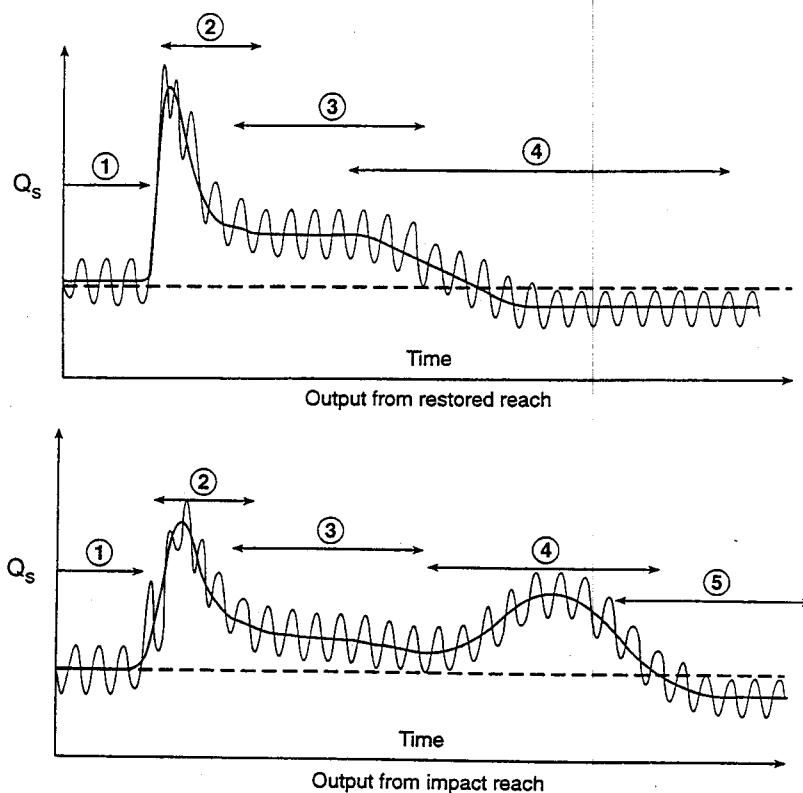
Figure 1. Model of sediment yields resulting from river restoration. 1: Pre-restoration - Dynamic equilibrium/aggradation; 2: Construction and aftermath - Erosion; 3: Colonisation and adjustment - Stabilization; 4: Overbank conveyance - Floodplain accretion.

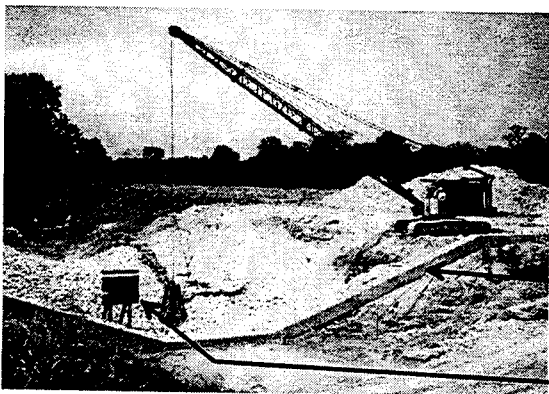
Concrete Sill

Wooden baffle

Grade control structures consist of a concrete or steel sheet piling sill and a rock lined basin. A wooden baffle is installed in the stilling basin to dissipate energy.

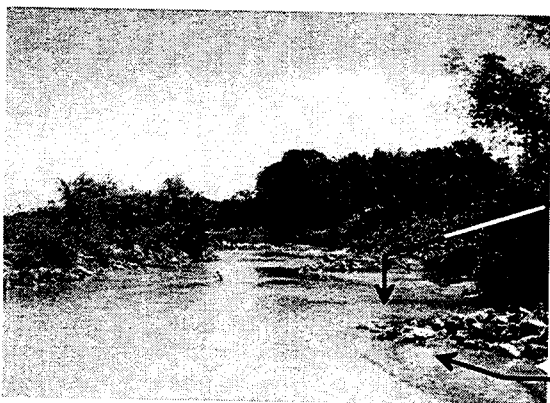
Spur Extension

Scour Hole

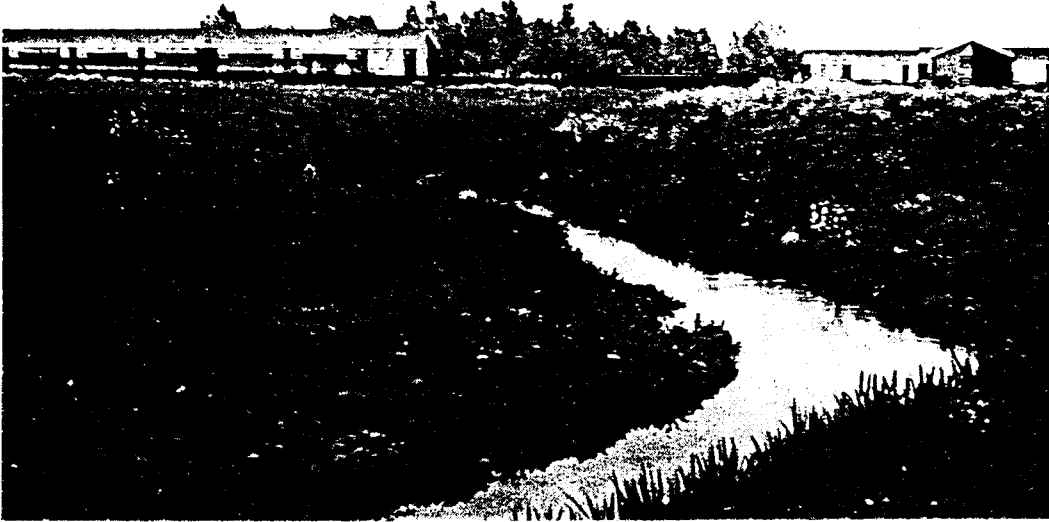
Figure 1. Stretch of River Alt after rehabilitation scheme.

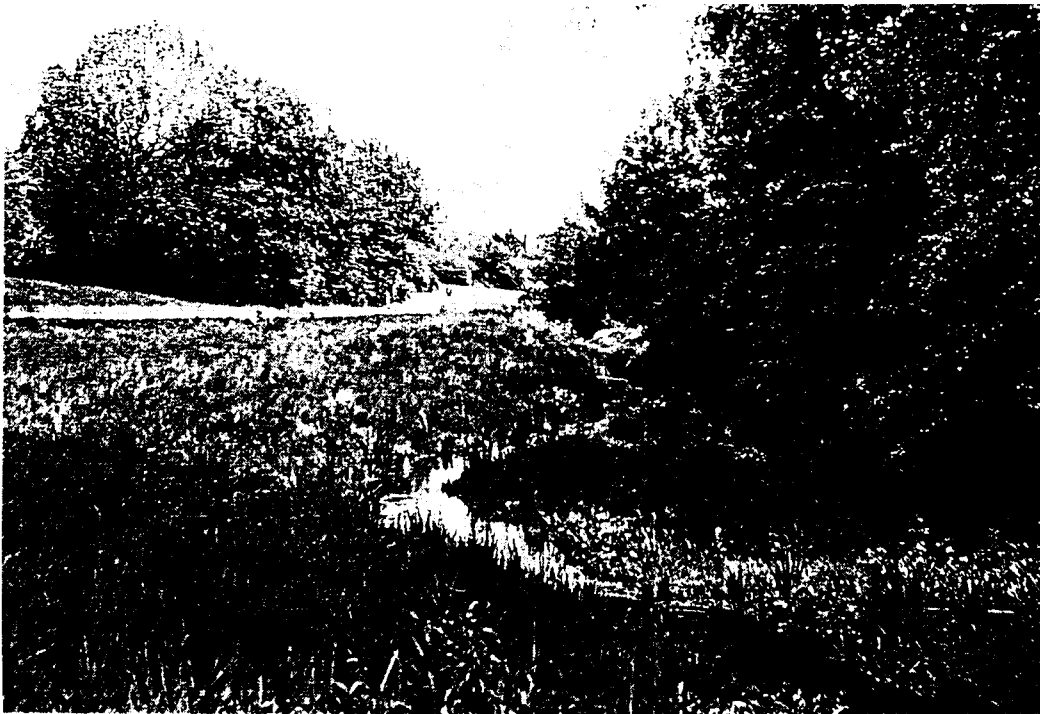
Figure 2. Stretch of Whittle Brook after rehabilitation scheme.
