## Classification system for watercourse rehabilitation

### Proposal for a classification system

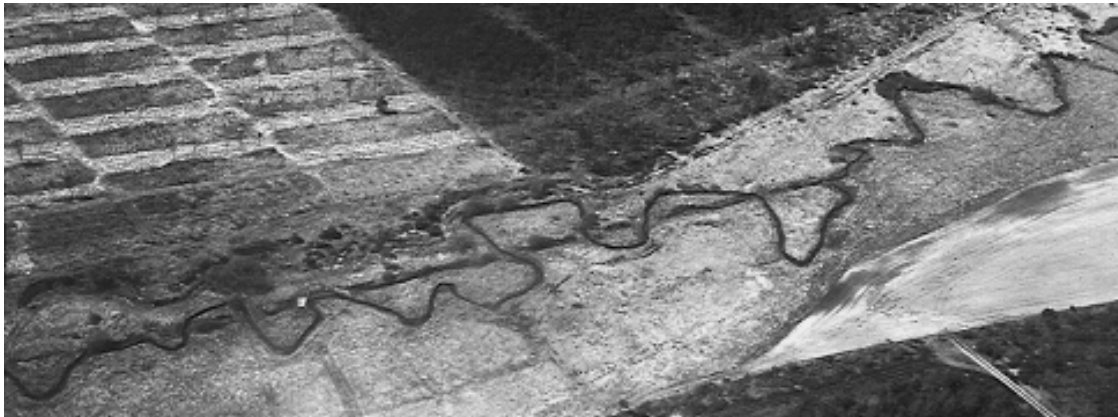
Figure 4.3. A *two-step cross-sectional profile* ensures an adequate water depth and current in dry periods.

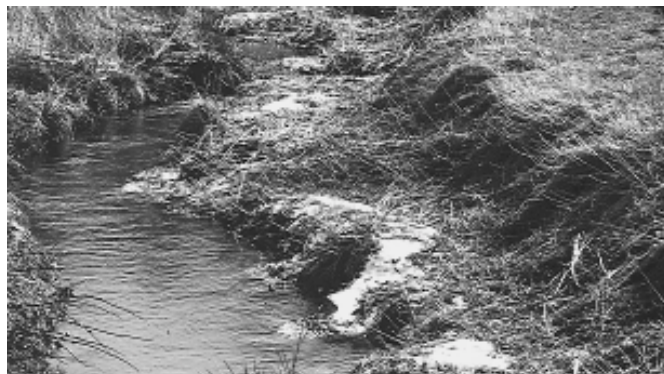
Figure 4.2. *Remeandering of watercourse reaches* can serve several purposes, and is therefore included under all three rehabilitation project types. Under type 1, remeandering creates more varied habitats in the watercourse, among other things because of the resultant alternation between deep and shallow parts and weak and strong current. In addition, the current in meandering watercourses hinders sanding over of the gravel and stones.

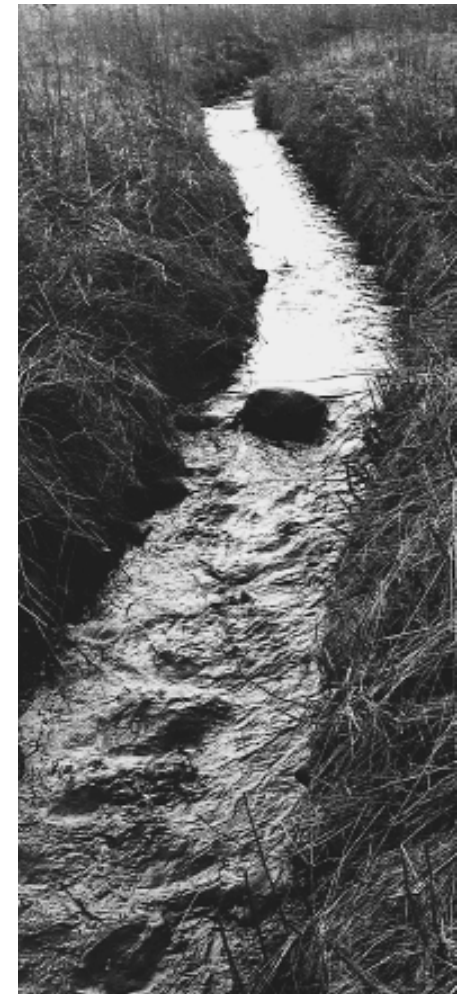
Figure 4.4. *Stones* provide hiding places for fish and habitats for stream macroinvertebrates. They also improve habitat conditions by causing currents such that the water becomes oxygenated.

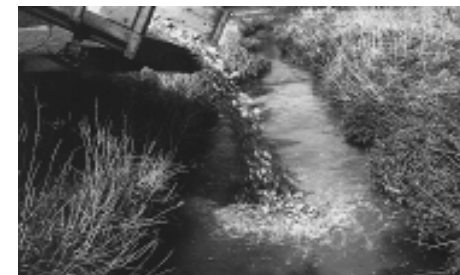
Figure 4.5. *Gravel banks* serve as spawning grounds for fish and as a habitat for stream macroinvertebrates.

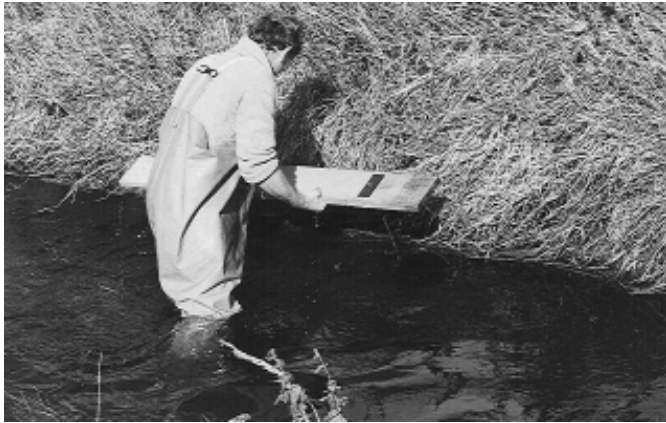
Figure 4.6. Setting up *artificial hiding places for fish* was one of the original rehabilitation methods allowed under the Danish Watercourse Act, but is seldom used nowadays.

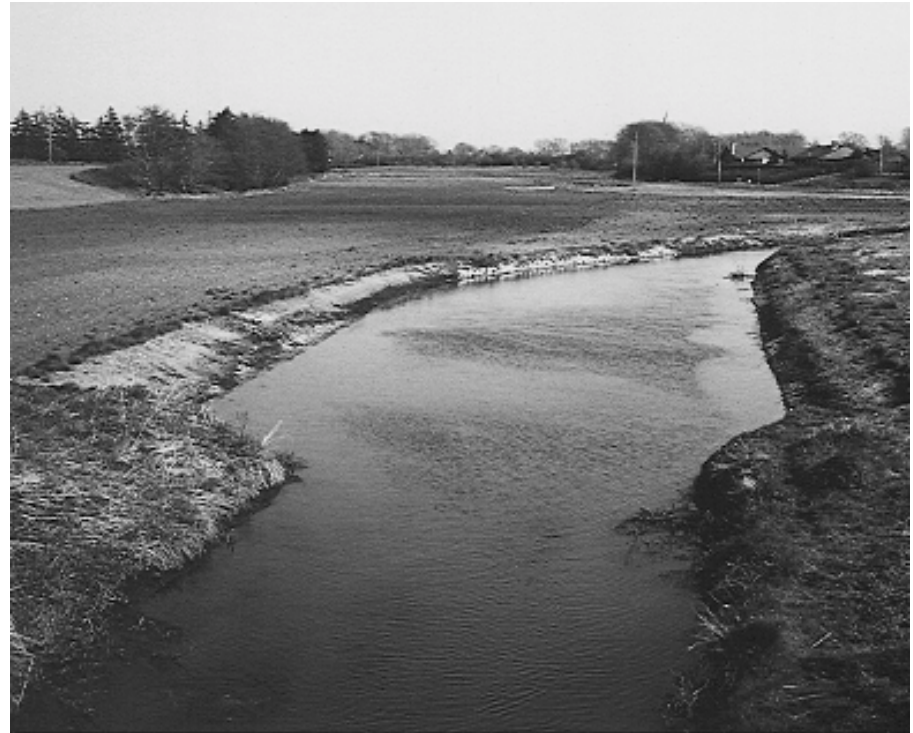
Figure 4.8. *Sand traps* reduce the transport of sand in watercourses.

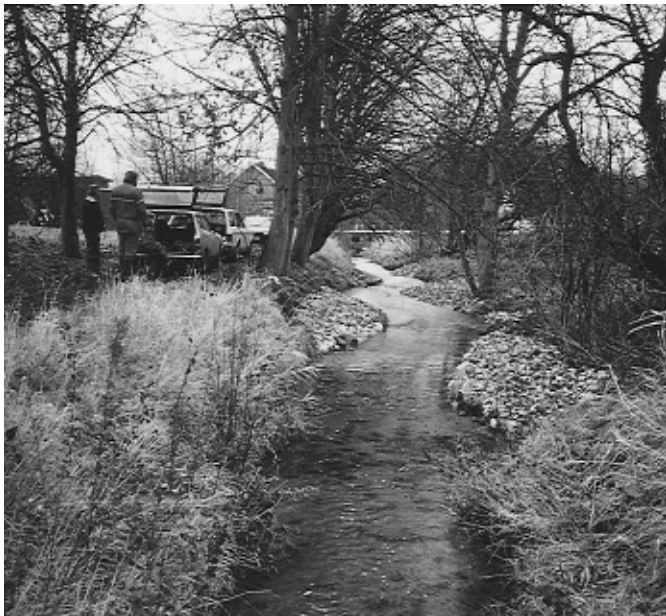
Figure 4.9. *Trees and bushes planted within the 2 metre cultivation-free border zone* can stabilize the banks and create hiding places for fish. In other places, it can be an advantage to remove trees and bushes.

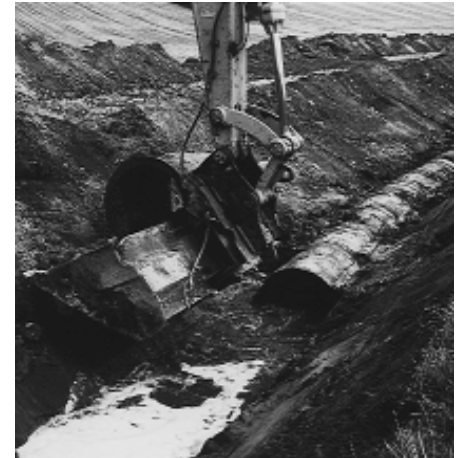
Figure 4.10. *Obstruction replaced by a riffle.*

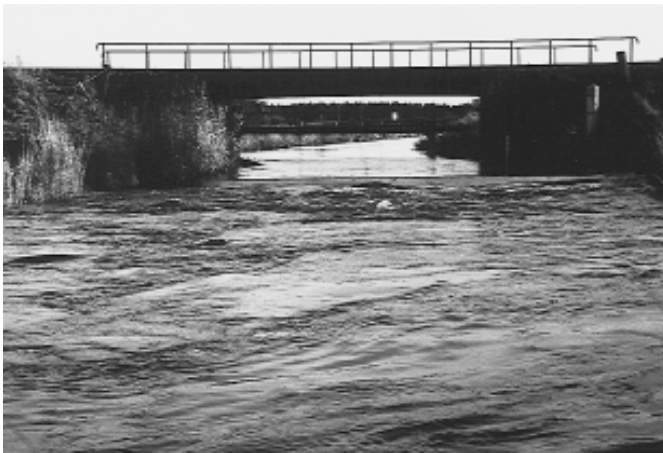
Figure 4.11. *Bypass riffle established at preserved obstruction.* In cases where one wants to preserve an obstruction, e.g. a hydroelectric power station or a historical water mill, but at the same time ensure free passage to the fauna, a solution can be a bypass riffle.

Bypass riffles around preserved obstructions not only permit free passage for fish and stream macroinvertebrates, but may also provide good habitats for trout. Investigations of the trout population in newly established riffles and bypass reaches in Vejle County show that there is often a markedly larger population in riffles and bypass reaches than in the upstream and downstream reaches (7). The reason is probably better physical conditions in the form of hiding places and current breakers, as well as the fact that the stones laid out ensure a good food resource with a rich population of macroinvertebrates.

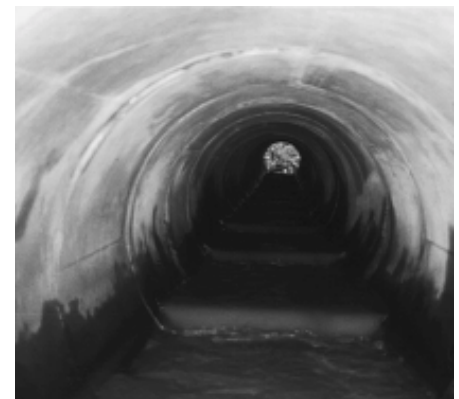
Figure 4.13. *Current breakers in underpass culverts.* In order to enable fish to pass through a culvert one can raise the stream water level and insert current breakers.

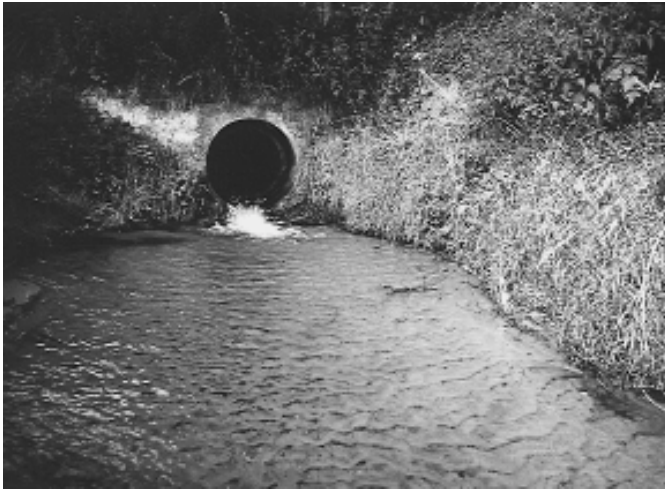
Figure 4.14. *Falls evened out at culvert outlet.* In cases where the outlet of a culvert, e.g. at a road underpass, is higher than the stream water level (left), one can establish a short riffle or lower the culvert to the level of the stream (right).

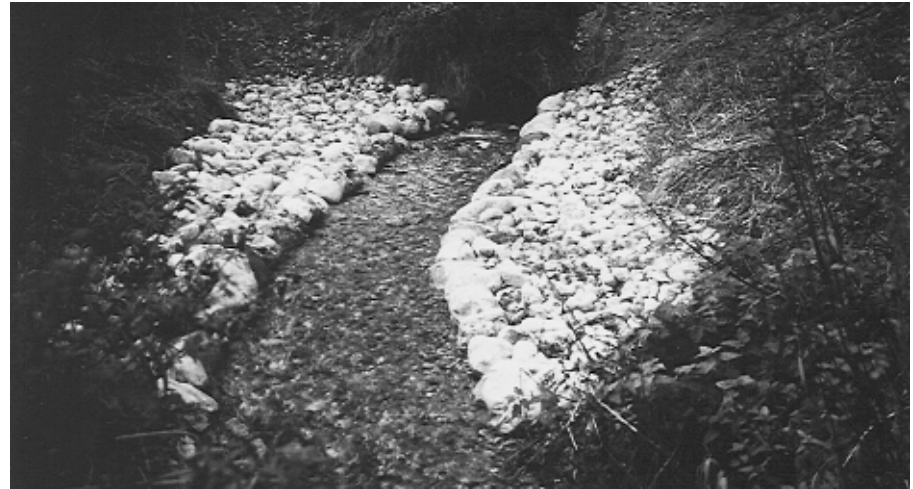
Figure 4.15. *Fish ladders* were one of the first Danish rehabilitation measures undertaken, but are now only used in cases of need, for example if there is insufficient space to establish a bypass reach. A watercourse reach can also be improved by removing a fish ladder and replacing it with a riffle or a bypass reach.

etc. On the other hand, though, it can still be necessary to establish fish ladders if there is insufficient space to establish a riffle or a bypass reach.

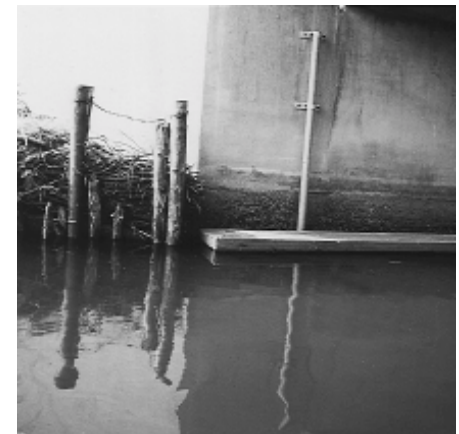
Figure 4.16. *Otter pass.* This is a type 2 rehabilitation method that helps otters to pass under bridges. Many otters are killed by vehicles in Denmark when trying to cross roads over streams.

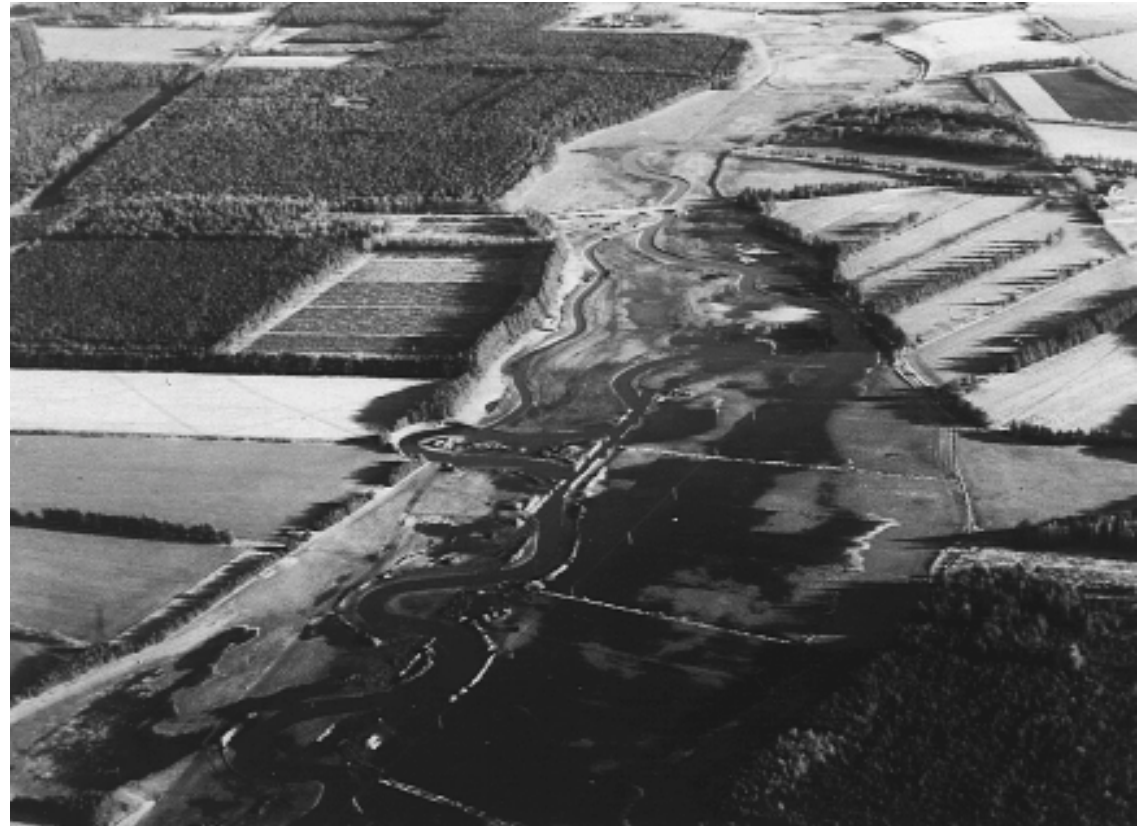
Figure 4.17. *Water table and flooding frequency increased by raising the bed.* One can also raise the water table and increase the frequency of flooding by raising the watercourse bed, for example by establishing high riffles (shown here during a dry summer).

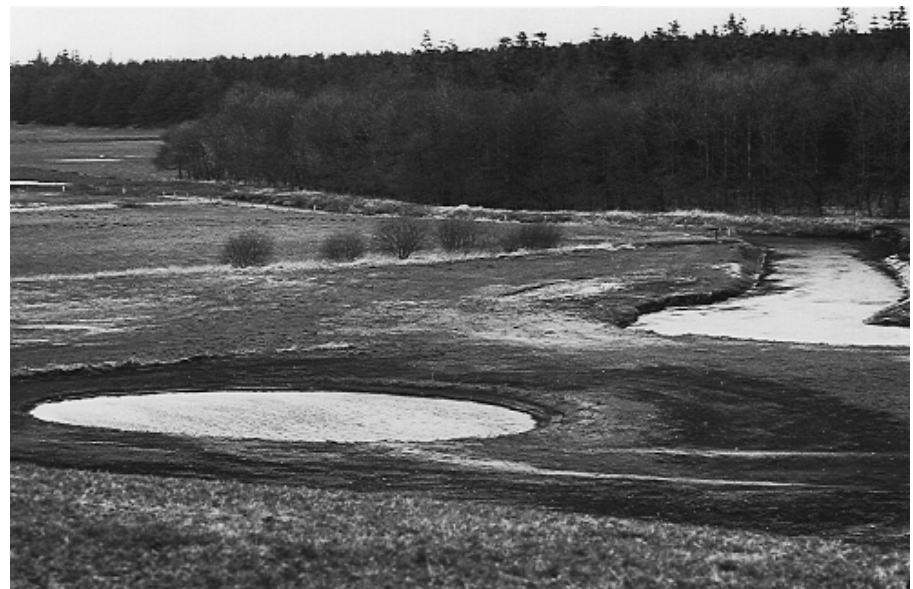
Figure 4.18. *Water table and flooding frequency increased by remeandering the watercourse.* One can raise the water table and increase the frequency of flooding by remeandering the watercourse.

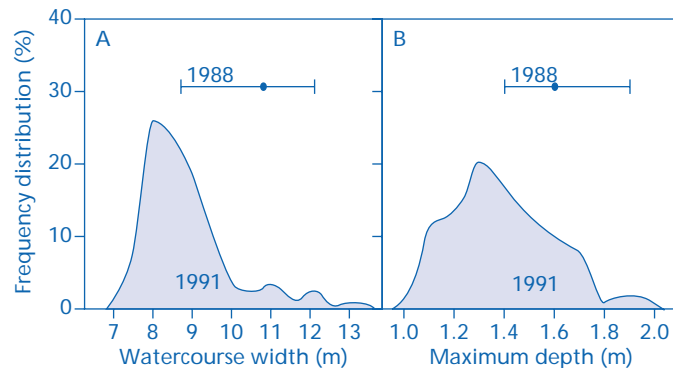
Figure 5.1. Variation in the width (A) and maximum depth (B) of Gelså stream before (1988) and after (1991) remeandering. Stream width varied from 9–12 metres in 1988, and from 7–14 metres in 1991. Stream maximum depth varied from 1.4–1.9 metres in 1988, and from 1–2 metres in 1991. Thus on average, the watercourse has become narrower and more shallow after remeandering, thereby increasing the possibility of flooding.

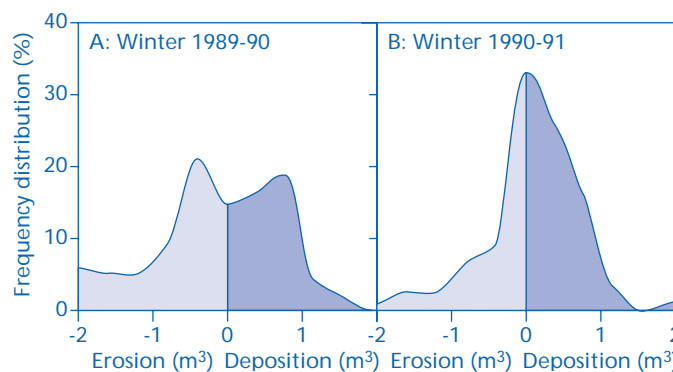
Figure 5.2. Erosion and deposition of bed material in Gelså stream during the first (A) and second (B) winter after remeandering. The figure is based on precision surveyance of 120 cross-sectional profiles.

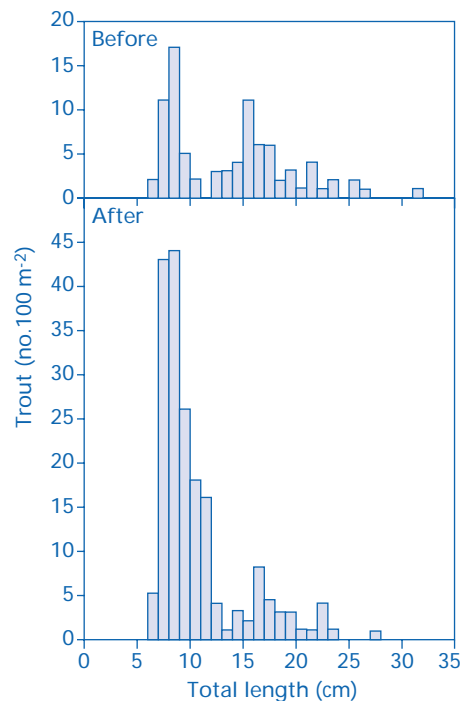
Figure 5.8. Number and size distribution of trout in Truds stream before and after passage was opened to additional upstream spawning grounds (10).

the trout. This changed the current conditions so much that the trout were once again able to swim through the culvert. In the subsequent spawning season, the spawning grounds upstream of the culvert were also utilized, and over-utilization of the downstream spawning grounds ceased. As a result, considerably more eggs and fry survived, the carrying capacity of the stream having been better utilized (Figure 5.8).
