# 3

Examples from  
the Danish  
counties

Editor:  
Hans Ole Hansen

Nordjylland  
County

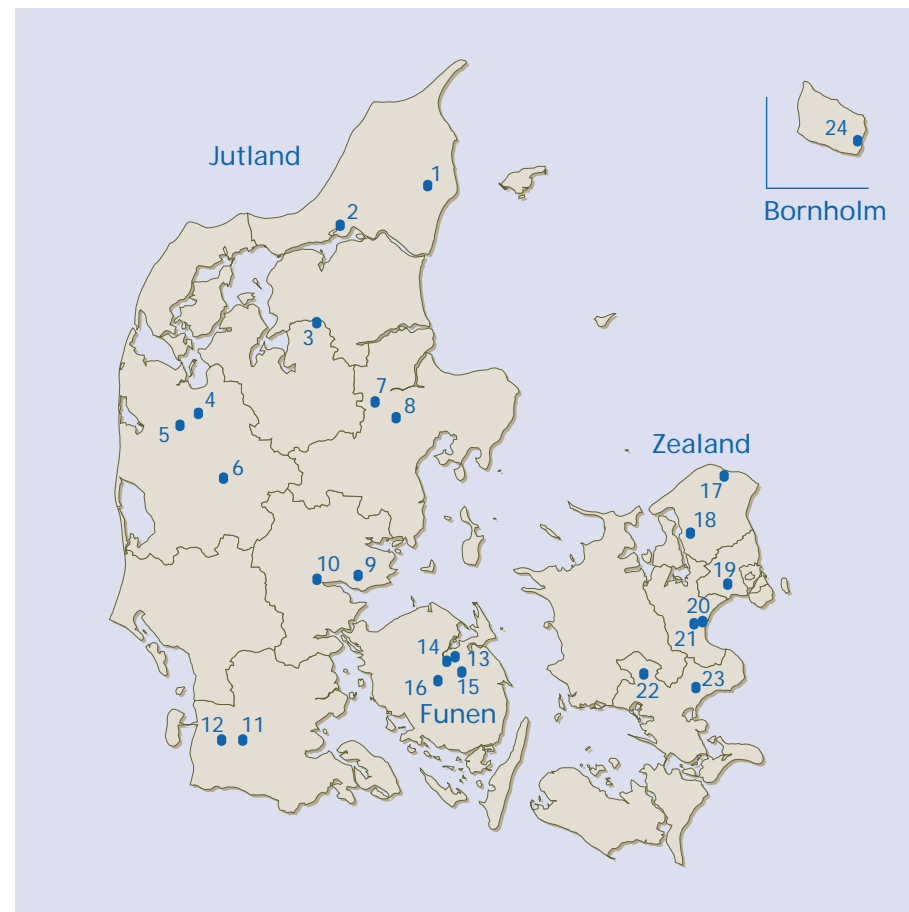
The geographical  
position of the 24  
examples described.

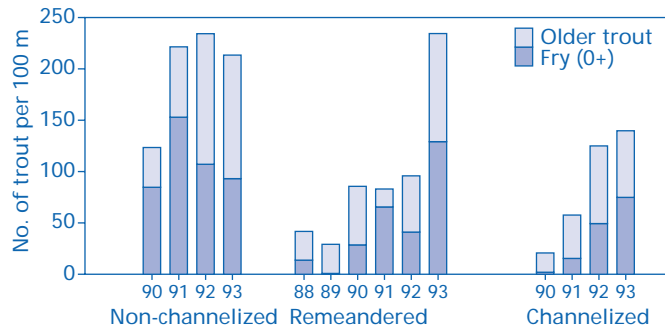
Sketch map of the remeandered course of Idom stream.

stations. Station 1 lies downstream of the restored reach and has never been channelized, while station 2 lies in the restored reach and station 3 lies upstream and is still channelized (see the figure). It should be noted that electrofishing in 1990 was undertaken immediately prior to restoration in October, and that the trout population at station 1 has not been investigated before 1990. Between 1990 and 1991, the number of trout in the 100 metre reach at station 1 almost doubled, and has since remained constant at around 225 trout, which corresponds to a density of approx. 1 trout m<sup>-2</sup>. This level probably represents the trout carrying capacity that the stream has in its non-channelized form. Similarly at station 2, the trout population has increased from 25 trout in the 100 metre reach in 1989 to approx. 225 trout in 1993. At station 3, the trout population increased from just under 25 trout in 1990 to just under 150 trout in 1993.

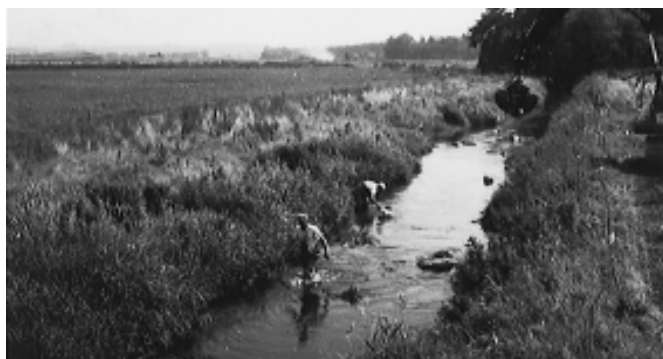
Laying out stones in a two-step profile.

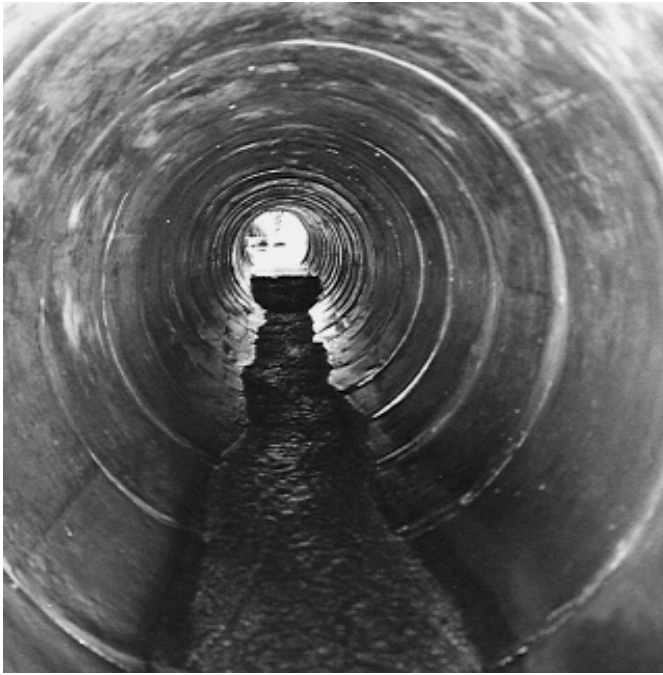
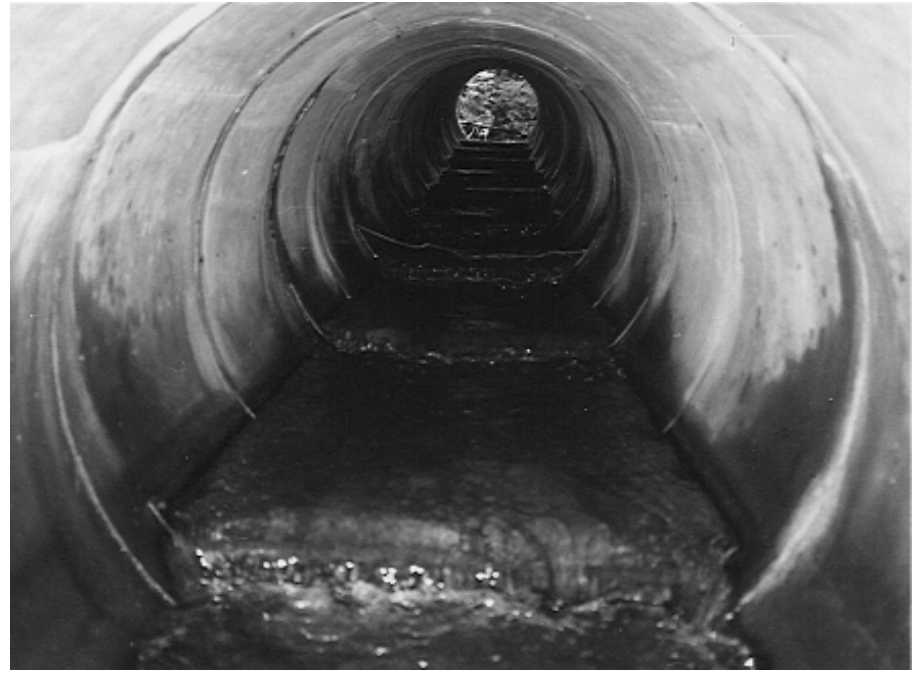
The road culvert before and after mounting the lamellae.

Culverts that lead watercourses under roads are one of the most common obstructions in smaller Danish watercourses. If there is insufficient water in the culvert, or if the current is too strong, the culvert forms an effective obstruction for even the strongest swimmers such as a sea trout. If the culverts lie deep below the road surface it is often economically unfeasible to alter them. Mounting

lamellae in culverts has proved to be a very effective means of raising the water level and reducing current velocity. Moreover, it is a relatively cheap solution for a major problem.

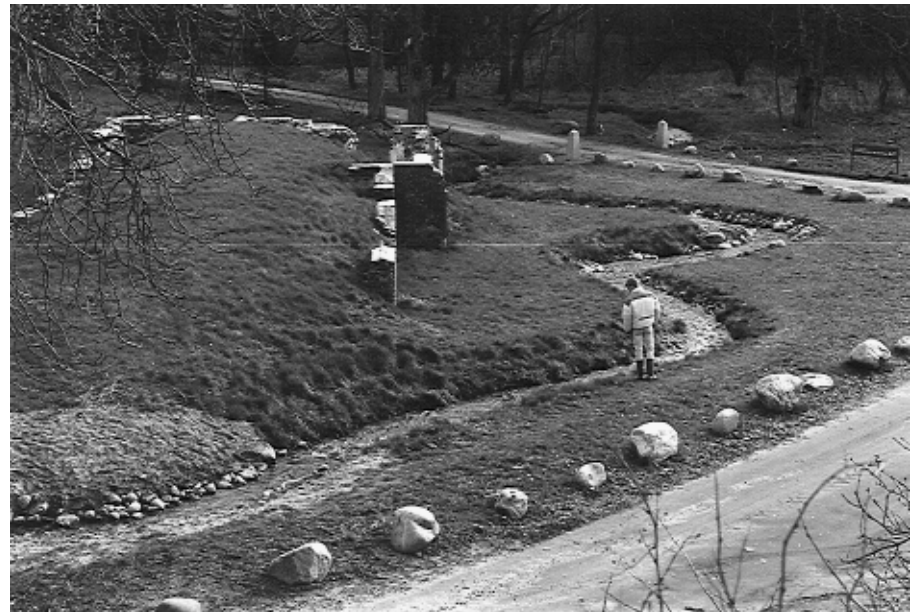
Bypass riffle at Kvak  
Watermill.
