River Brede at Bredebro

Watercourse system:
River Brede

Introduction to the project

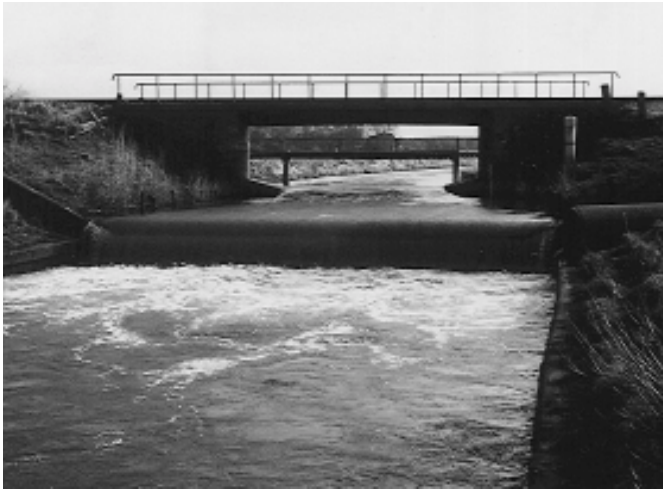
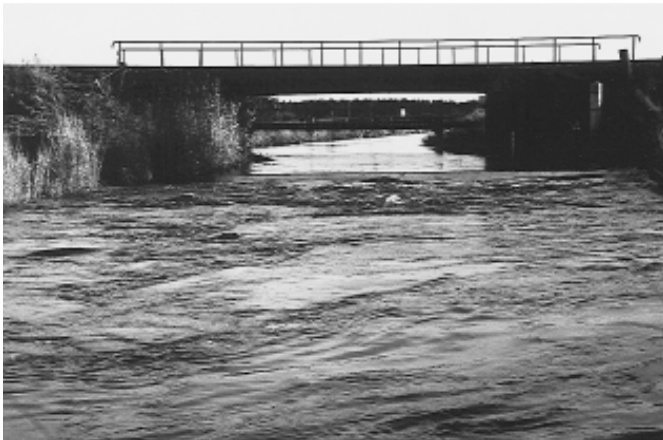
The weir at Bredebro prior to and following conversion to a riffle.

The project was undertaken in late summer 1990. The original concrete weir was not altered. Immediately downstream of the weir, a 250 metre long riffle was

created with an average slope of 5‰. The riffle is comprised of three sub-riffles with a total length of 110 metres. The three sub-riffles each have a slope of 10‰ and a bed width of 4 metres as compared with 6 metres in the parts between the sub-riffles. This arrangement creates two resting pools between the three sub-riffles. Downstream of the riffle spawning grounds have been established for trout and salmon.

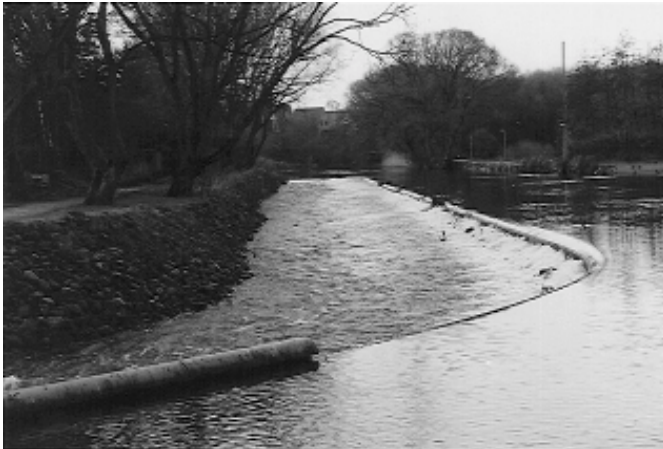
Riffle and spillway viewed facing upstream from the floodgate.

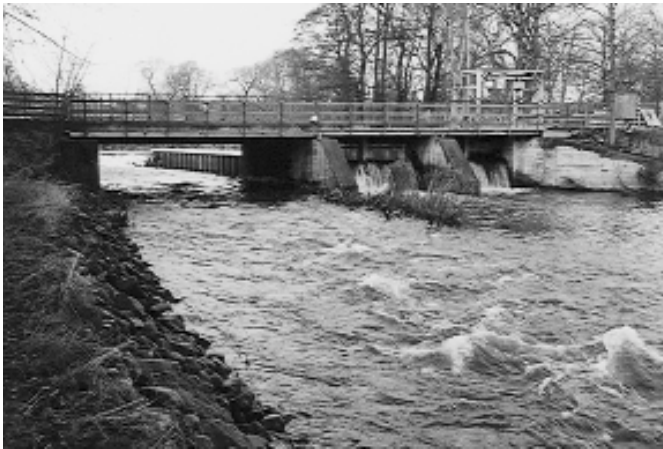
The riffle and floodgate viewed facing upstream from the lowermost resting basin.

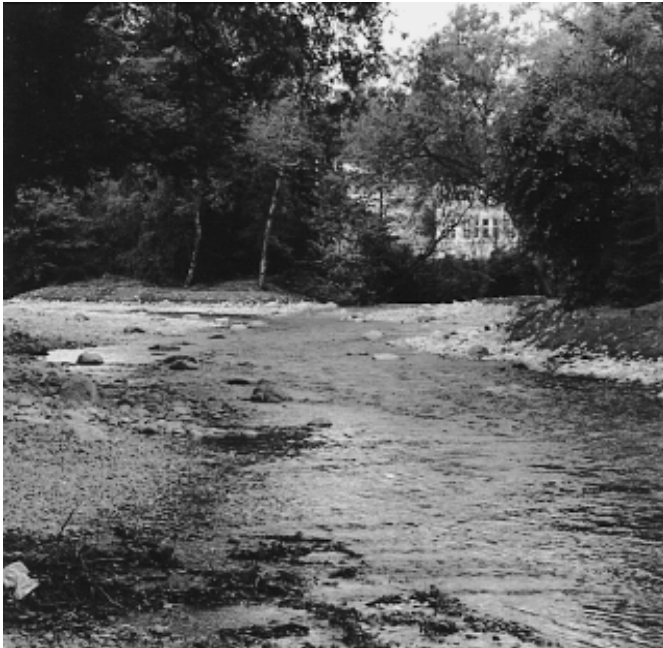
The riffle viewed facing upstream towards the island.

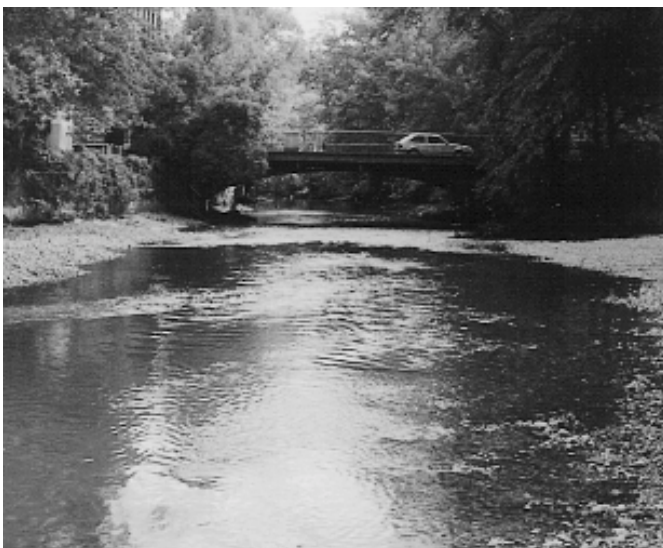
The spawning ground viewed facing downstream.

The northern of the two spillways was raised 10 cm. A large deep pool below the spillway has been preserved by damming the river slightly where it merges with the new riffle behind the island.

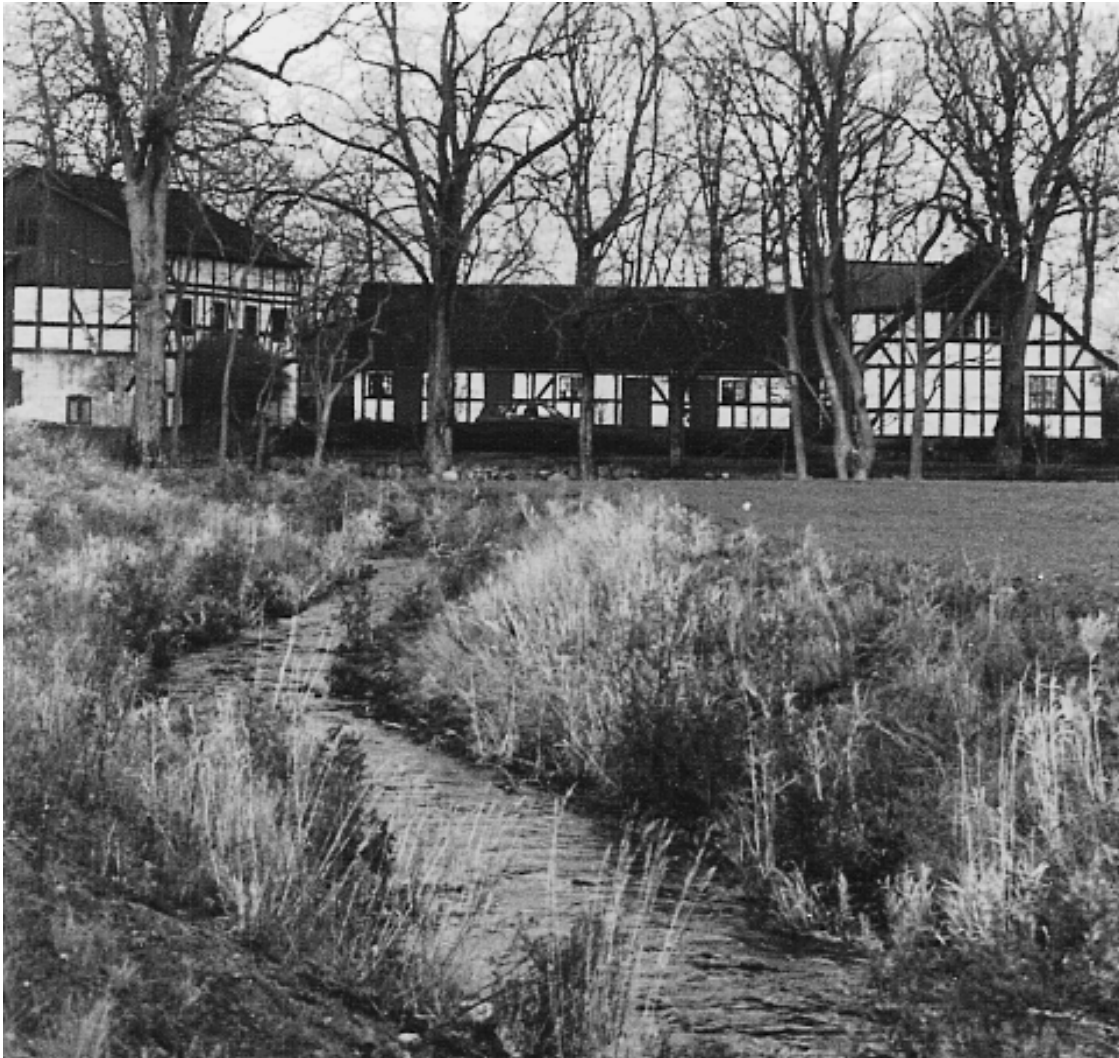
Sketch map of the course of the stream before and after rehabilitation (scale approx 1:20,000).

The new course of Lindved stream was approx. 2 km long (see sketch map). The stream was led through the newly established "prehistoric landscape" along part of the former path of the watercourse Parkvandløbet. This reach of the watercourse has a very flat cross-sectional profile and floods its banks in the winter. Two ponds were excavated that serve as sand traps. A new course was excavated through the forest after which the stream

runs under a newly constructed aqueduct that now leads Møllebæk brook along the former path of Lindved stream. From there the stream runs in part of the former course of Bagåen stream to a newly erected road bridge. From the road bridge to the water mill the new course has been constructed as a stone riffle thereby ensuring the fauna free passage around the millpond dam.

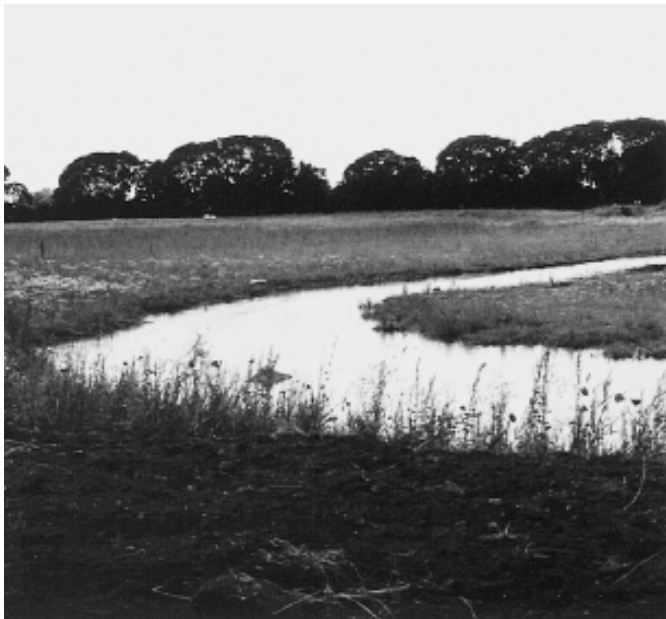
The newly established course of Lindved stream through the "prehistoric landscape".

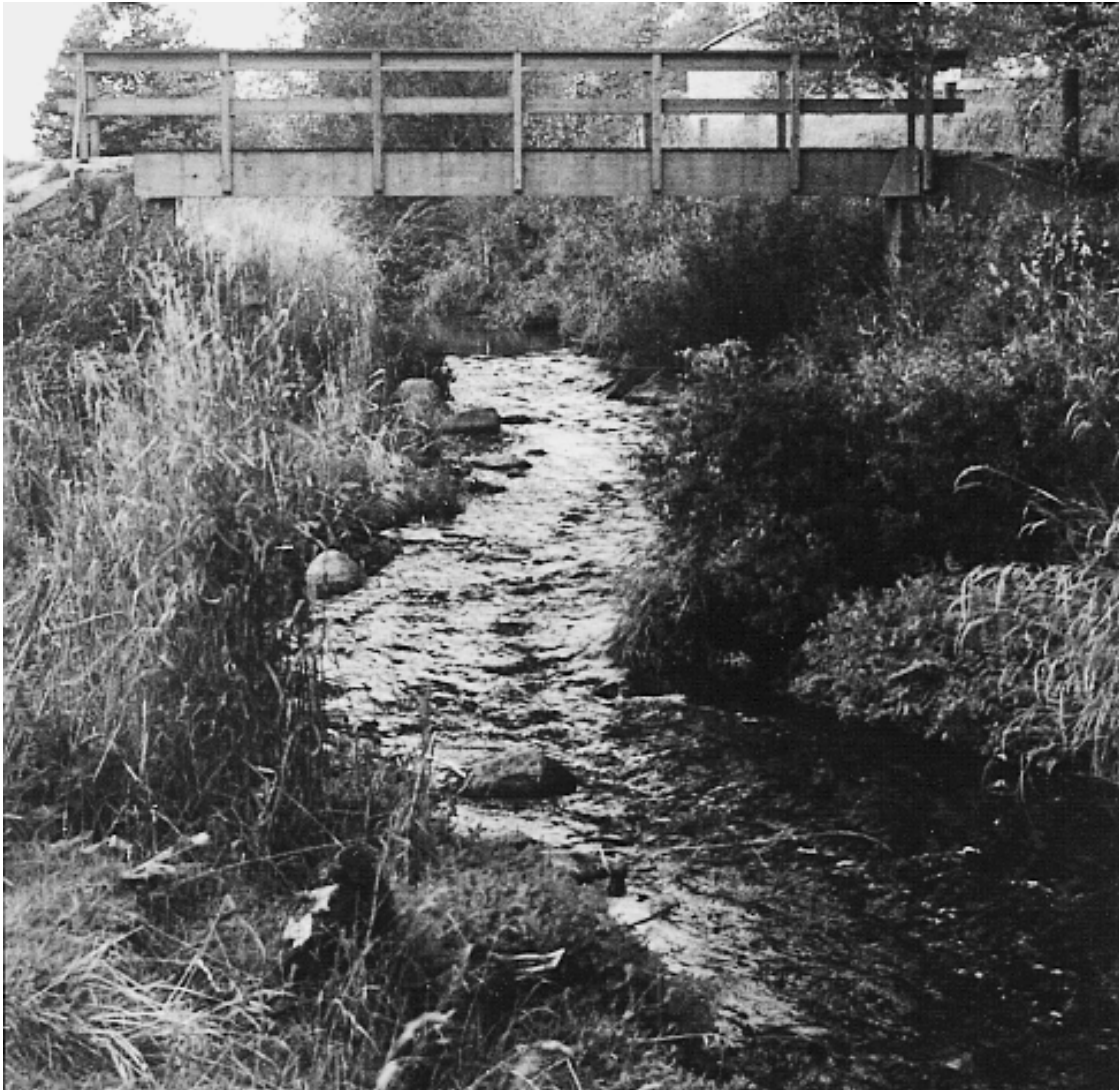
The riffle and modified sluice.

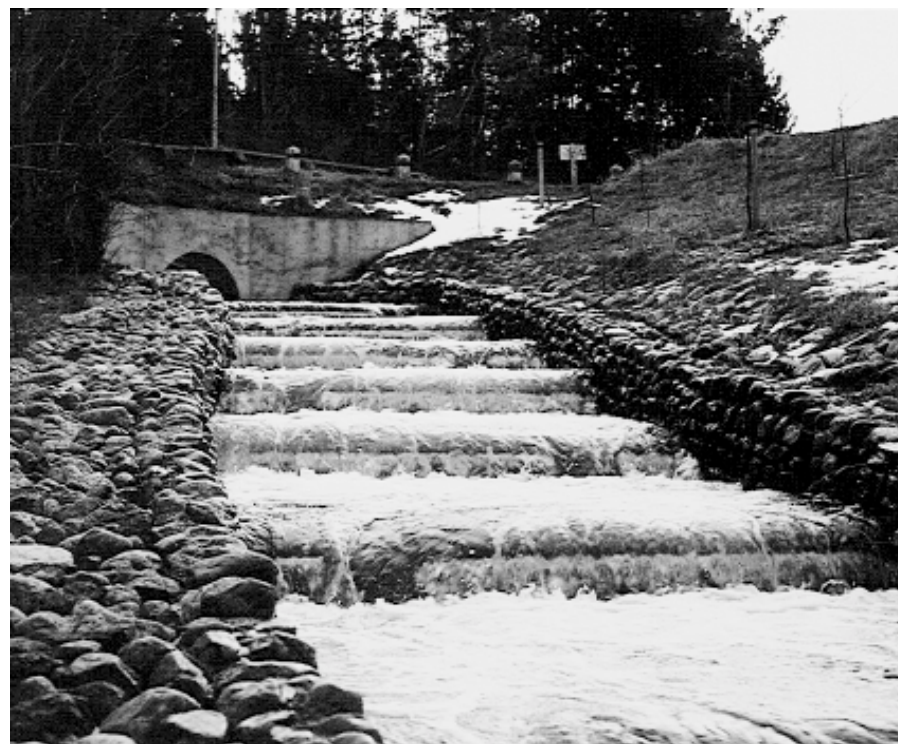
The basin ladder in Græse stream viewed facing upstream towards the road culvert.

The study initiated in 1991 led in 1993 to the establishment of a 125 metre long stone riffle upstream from the road bridge, and a basin ladder downstream from the bridge. The stone riffle was established with a small winding current channel in the watercourse profile in order to ensure a reasonable water depth during summer periods of low discharge. At the same time, the stream bed was

lowered such that the riffle fell evenly towards the road culvert. The planks in front of the road culvert were removed and a basin ladder constructed using 10 basins positioned such that there was a height difference of 31 cm between adjacent basins. In order that the basin ladder could blend into the surroundings as naturally as possible, the surfaces that would be visible above the water level were decorated with fist-sized pebbles. The basin ladder was fitted with an eel pass.

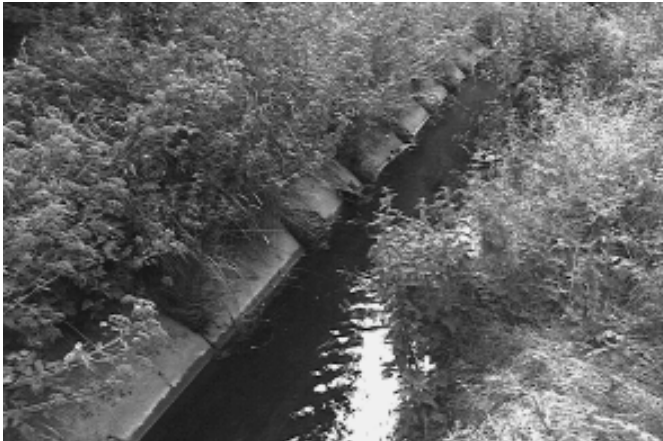
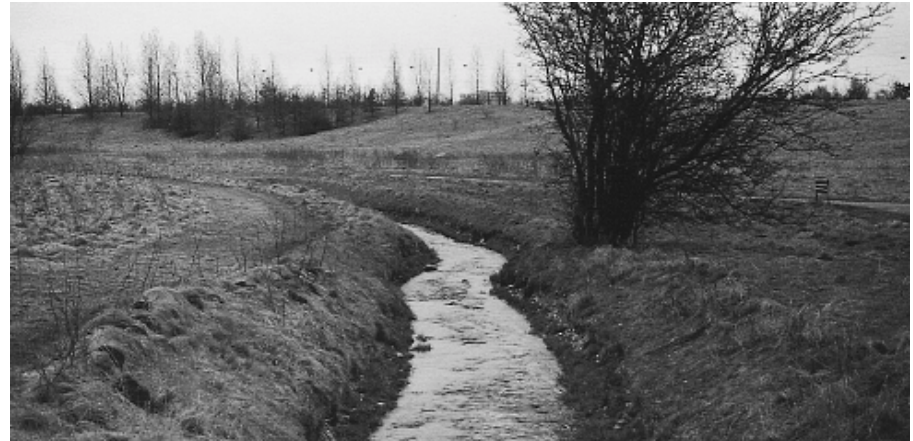
Store Vejleå stream before and after restoration.

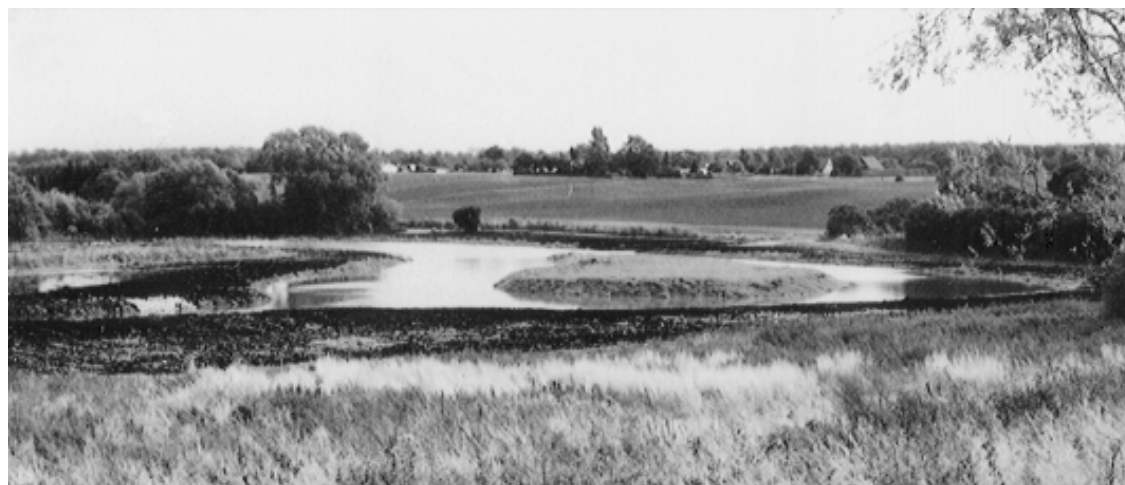
The sand trap on
Køge stream

The sand trap was established outside the main course of the stream such that part of the water ran through the main course, and part through the sand trap so as to ensure the discharge capacity stipulated in the Provisional Order governing the watercourse. A 10 metre long culvert was established in the main course dimensioned such that any discharge in excess of 200 l s^{-1} would run through the sand trap, and that there

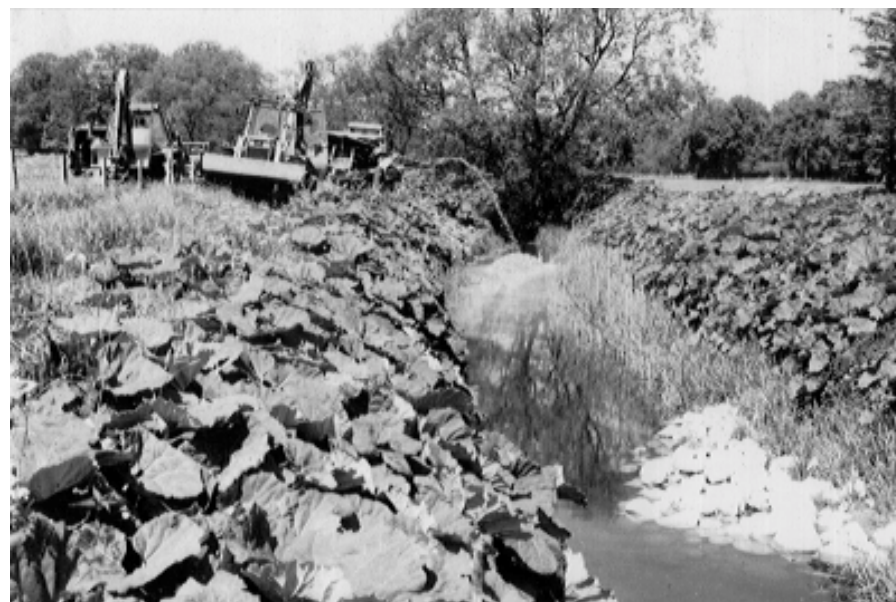
Laying out stones and spawning gravel in Køge stream.

prised three types of restoration measures as well as the establishment of spawning grounds and planting of vegetation alongside the stream. Type 1 comprised the laying out of stone heaps as well as individual large stones, and was undertaken in reaches where restoration was not allowed to reduce the drainage capacity. Type 2 comprised laying out stone heaps and gravel riffles, and was undertaken in reaches with a slope exceeding 2‰. Type 3 comprised the laying out of gravel beds and individual large stones, as well as large stone heaps as current concentrators, and was

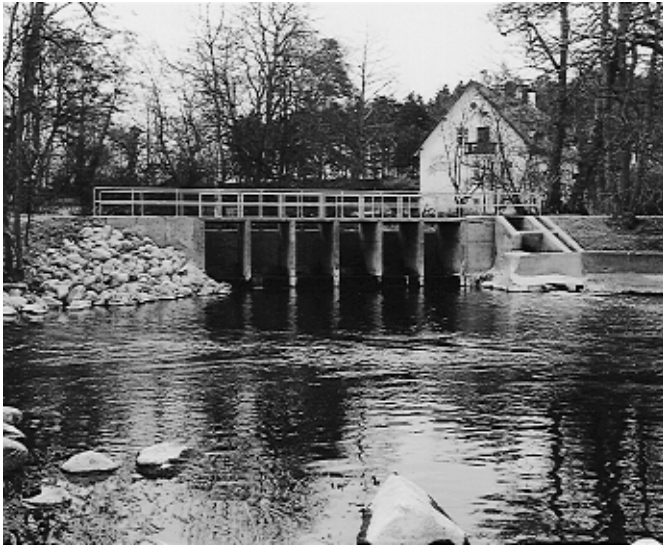
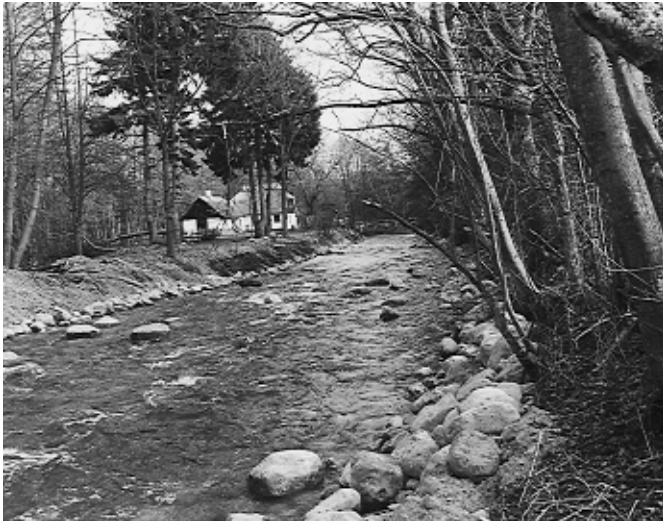
The sluice gate at Holløse Mill (upper) and the riffle at Daneskjoldske canal (lower).

The project was undertaken in winter 1992–93. The remainder of the main channel sluice gate with the eel trap was removed and replaced by a new, larger sluice gate. The fish ladder was preserved and shall primarily serve as a drop sluice for migratory fish. In connection with the project, approx. 1 km of dykes was renovated along the main channel.

The sluice gate in the secondary channel, "The Daneskjoldske canal", was dismantled and replaced by a riffle. The latter was sited in a manner that best preserved and protected the structures of historical interest. Since a false guide current can form at the main channel sluice gate during periods of high winter discharge, a current concentrator was constructed to guide the fish to the riffle. In addition, a new bridge was built over the canal to replace the road that once led over the dismantled sluice gate.

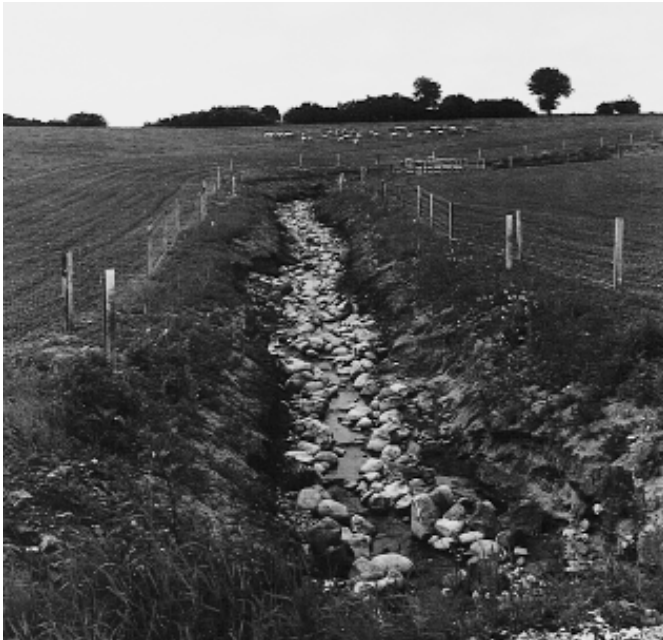
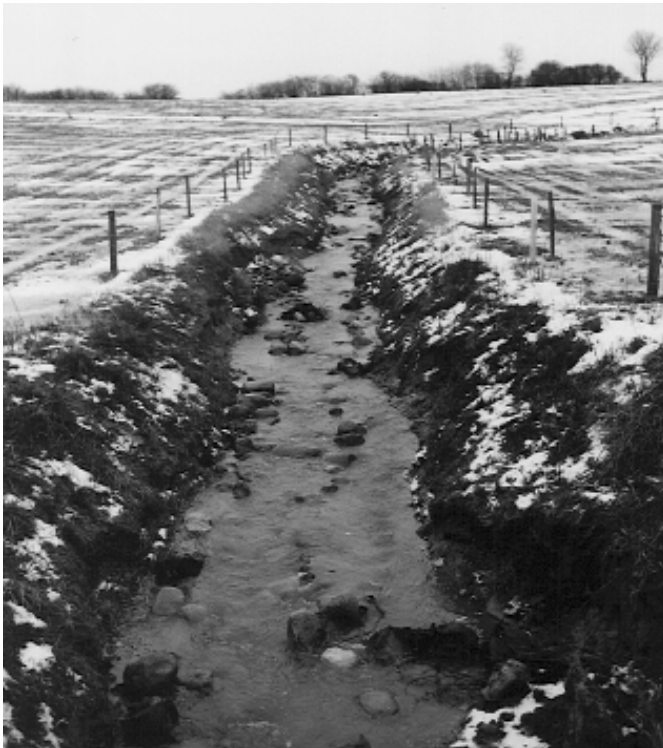
The new stream in summer 1994 (upper) and in winter 1995 (lower).

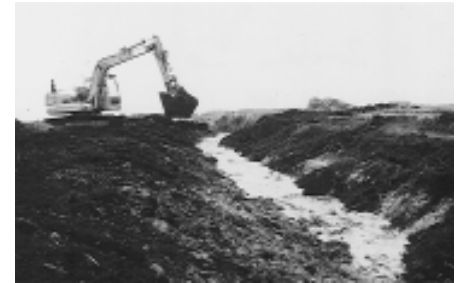
Restoration of Søbæk brook.

In the 1980s, it was observed that there was a sea trout population in the brook with several spawning grounds. However, the latter were threatened by sand migration, and the possibilities for maintaining the population were therefore limited. The aim of the project was to improve conditions for plants and animals in and around the watercourse by relaying the main channel along an approx. 350 metre reach and establishing a couple of small lakes.
